# Schedule of condition

| PROJECT | 12 Sample Road, London N1 |
| DATE OF VISIT | 16 October 2026 |

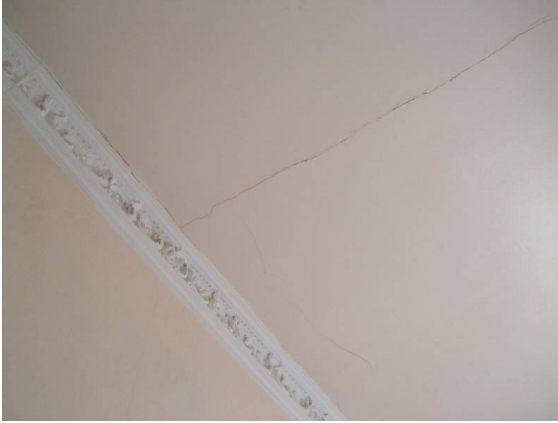
**Item 4**

Ceiling: cracks along the coving and ceiling junction, and at right angles across the ceiling, approx. 2 m.
